# Comparative analysis of the annual changes of land coverage of the “Cienaga de las Macanas” wetland

**Author: Andrea Santamaría Domínguez**

**Guaranteeing Water Security for the Forests and Wetlands of the Santa Maria River Watershed, Panama.**

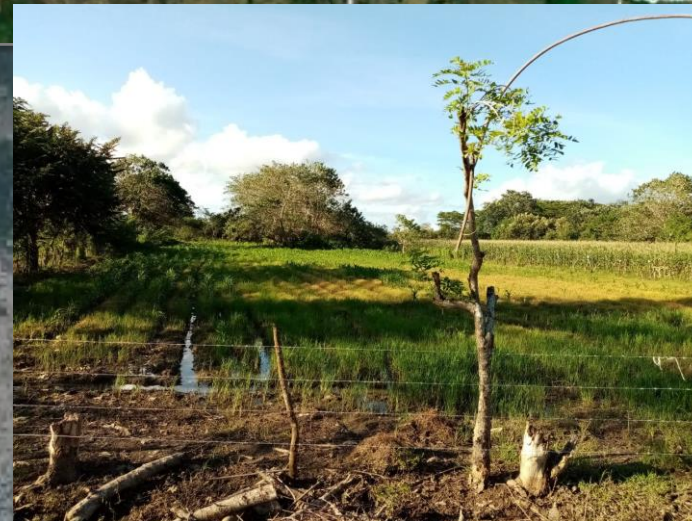
ESCALA 1:25,000

THE CIÉNAGA DE LAS MACANAS MANAGED RESOURCE AREA  
HAS AN SURFACE OF 857 HECTARES

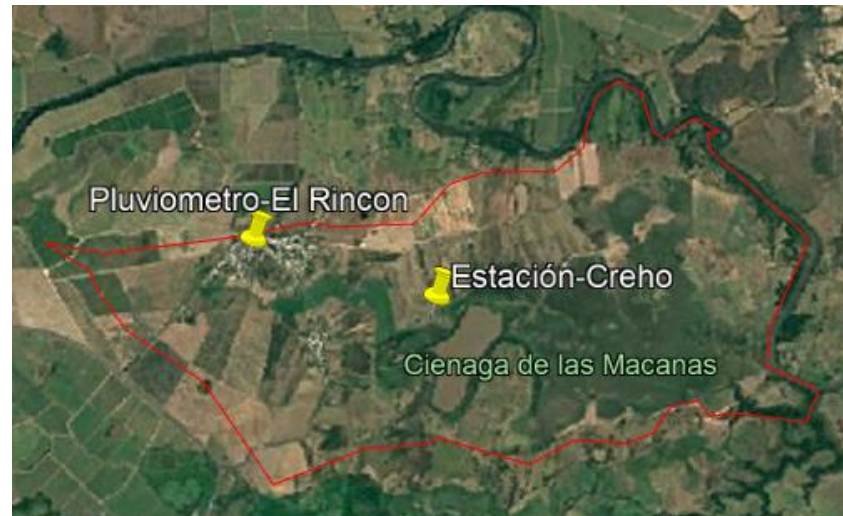
7km distance from the wetland

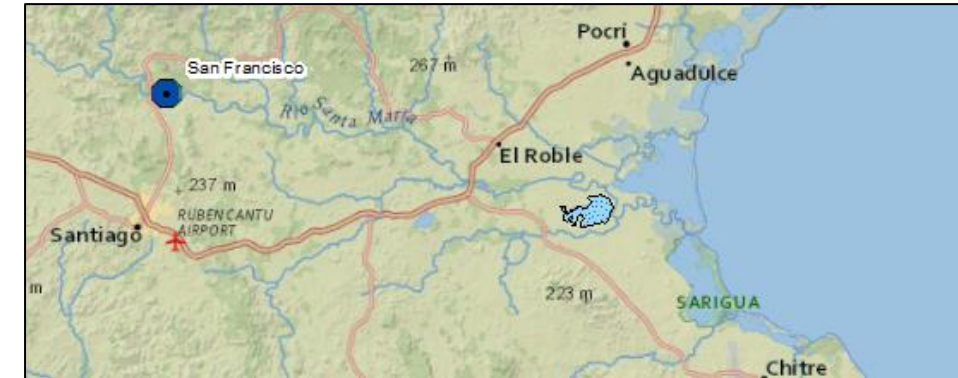
47km distance from the wetland

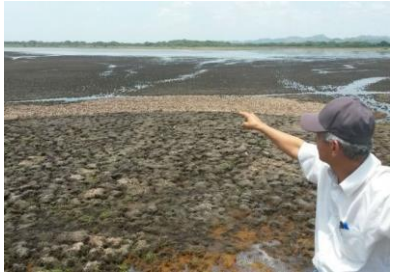
## 2015 — Extreme dry

- Porcentaje de flooded area 5% - 30%
- 10 months with images available

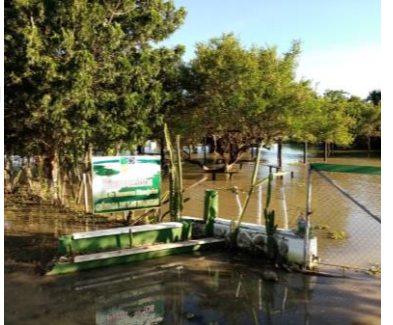
## 2021 — extreme flood

- Porcentaje de flooded area 25% - 56%
- 5 months with images available

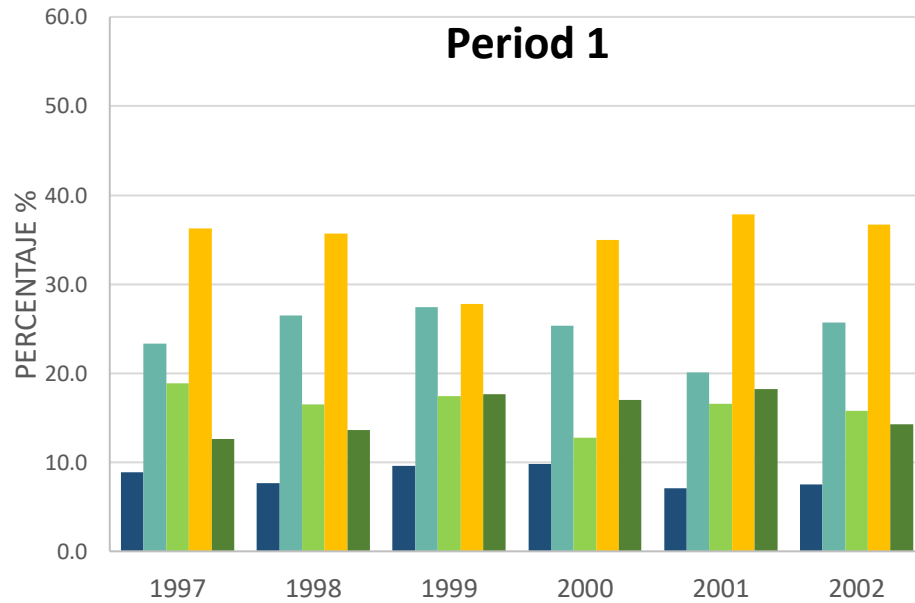
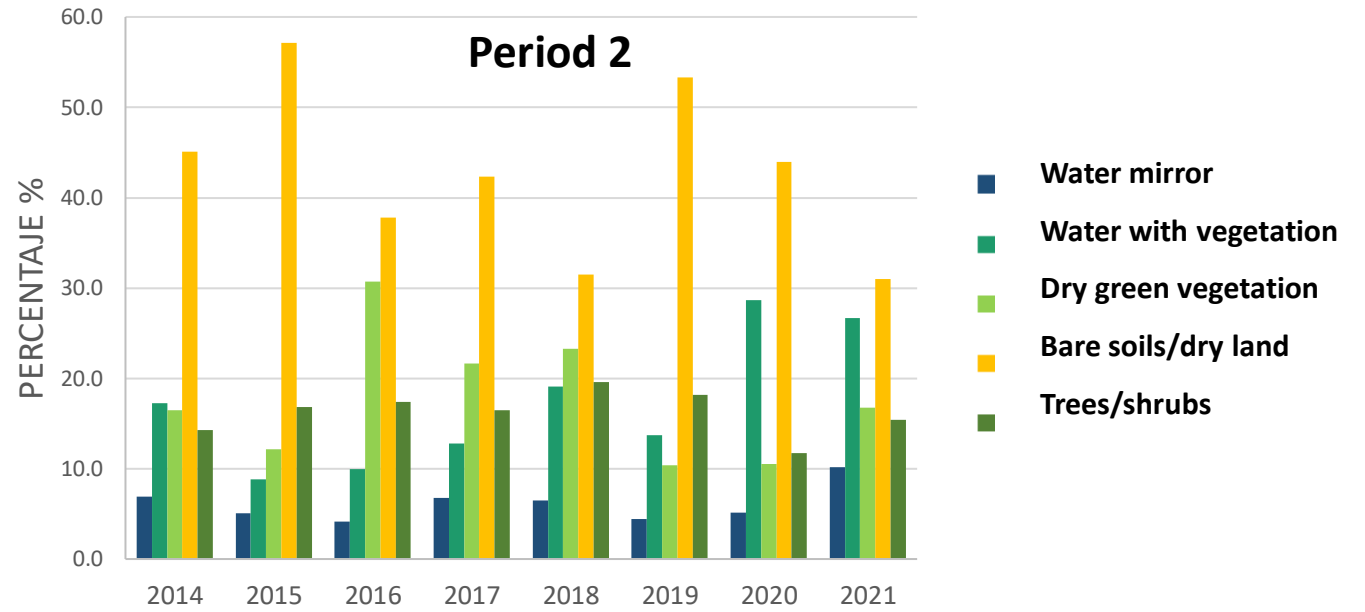
### Coverage percentage breakdown

**Water mirror:** 7.1% - 8.9%

**Bare soils/Dry land:** 27% – 36%

**Tress/Shrubs:** increase del 12% al 18%

**Water mirror:** 5.1% – 5.9% ; Recovery in 2021 (10.2%)

**Bare soils/Dry land:** 31% - 57%

**Tress/Shrubs:** Variation between 14% al 19%

- ✓ Supervised classification shows the increase in dry areas and bare soils in the surroundings of the wetland. As well as the decrease in the surface of the water mirror, caused by the increase in the coverage of aquatic plants on the water.

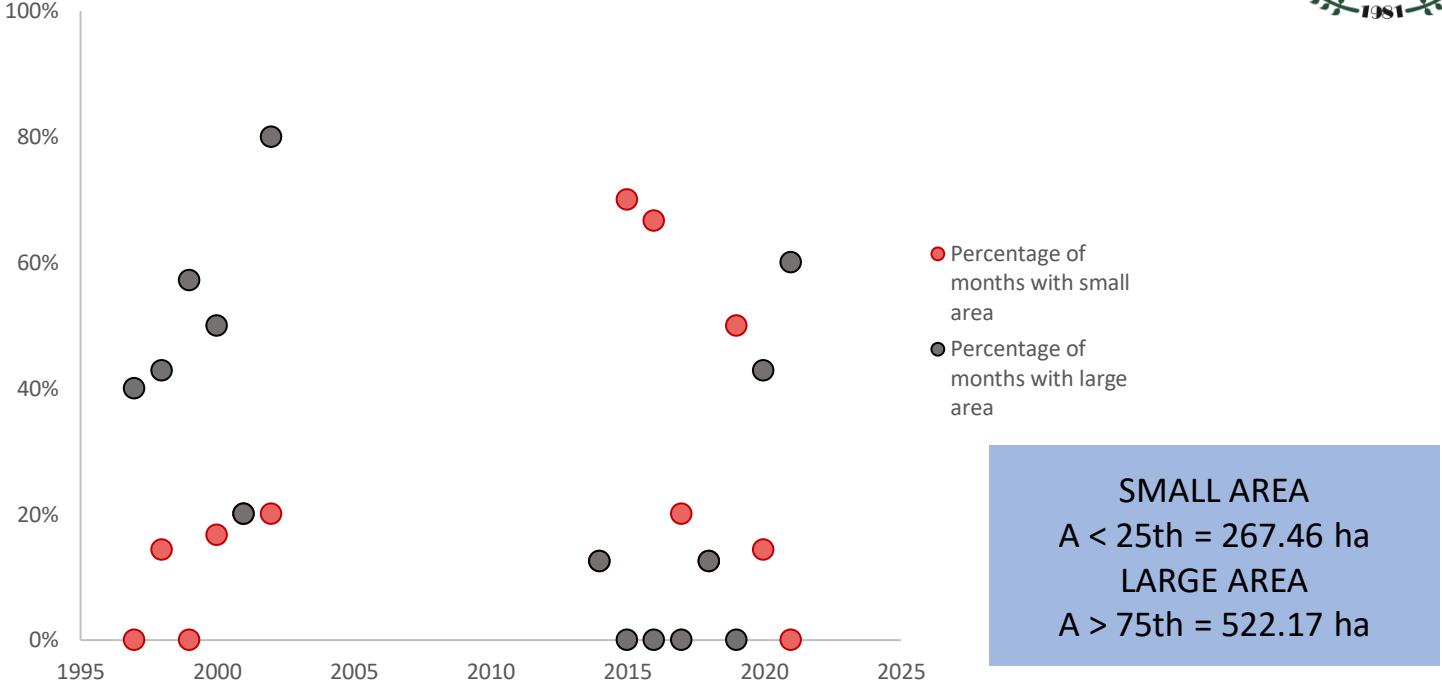
## Behavior of the flood area

- Decrease in flooded area in Period 2
- Area variability increased in period 2
- Recovery of the wetland area between 2020 – 2021
- Period 1 with the highest percentage of months with a large area

- ✓ The comparison between periods shows the notable decrease in the area flooded in recent years and a recent recovery in 2021. In addition, a greater variability in the surface of the flooded area, being less constant than the first period.

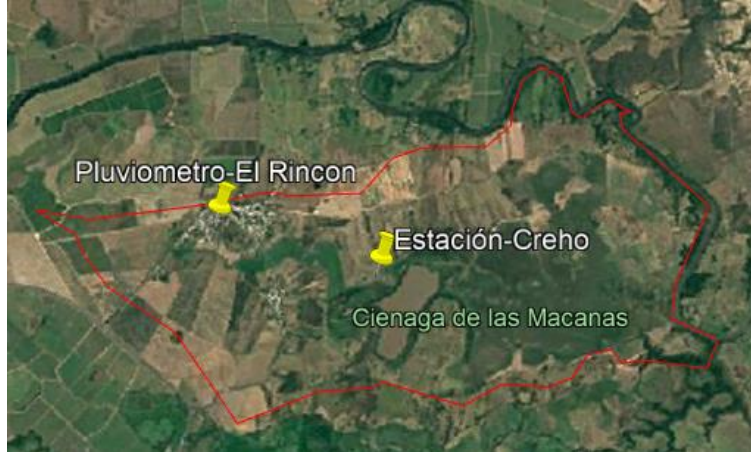
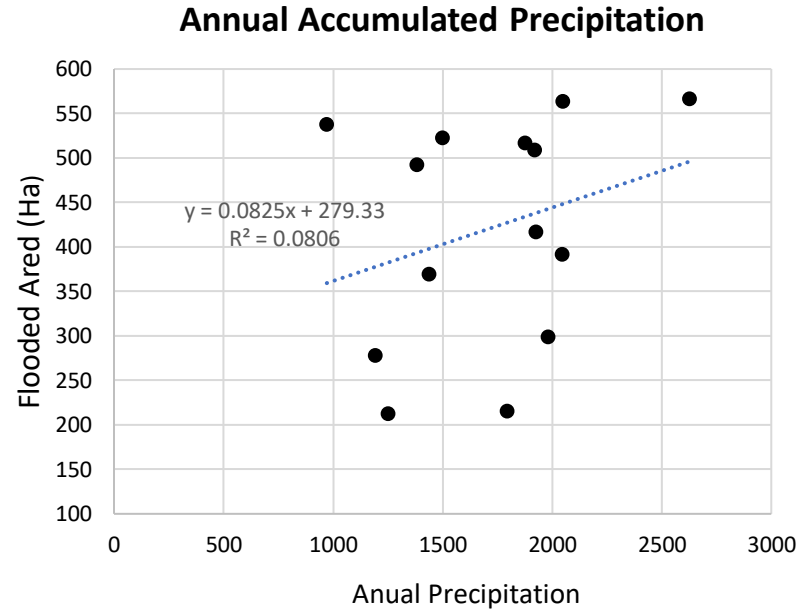
### Correlation of the flooded area with precipitation

7km distance from wetland

- ✓ About the influencing factors:
  - ✓ A certain influence of the interannual rains on the flood area is observed. Two consecutive years cause a greater subsequent impact on the wetland than one year alone.

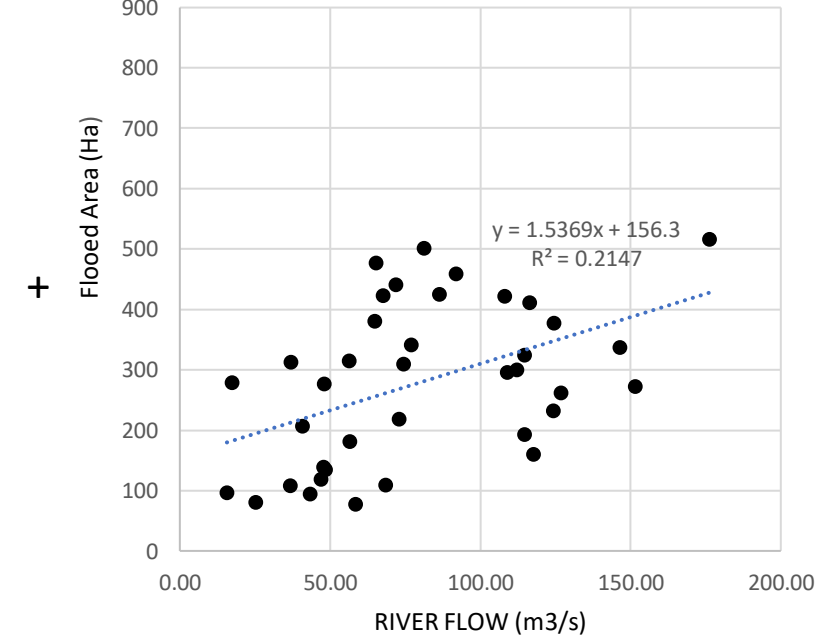
Period 2: 2014- 2021

### Correlation of flooded area with the flow of the Santa María River in the previous month

HIGHER CORRELATION

- ✓ The greatest effect is caused by the Santa María River, adjacent to the wetland, being an important inflow. And since the wetland is affected by the flow of the previous month, it means that there is a possible storage in groundwater.
